REAL AND SIMULATED CRASHWORTHINESS TESTS ON BUSES

ID: 05-0233

This paper discusses the design aspects of bus frontal impact behavior as one of the main subjects of bus crashworthiness and surveys conditions and results of previous full impact laboratory tests comparing the FEM simulation results carried out on a Hungarian Ikarus bus.

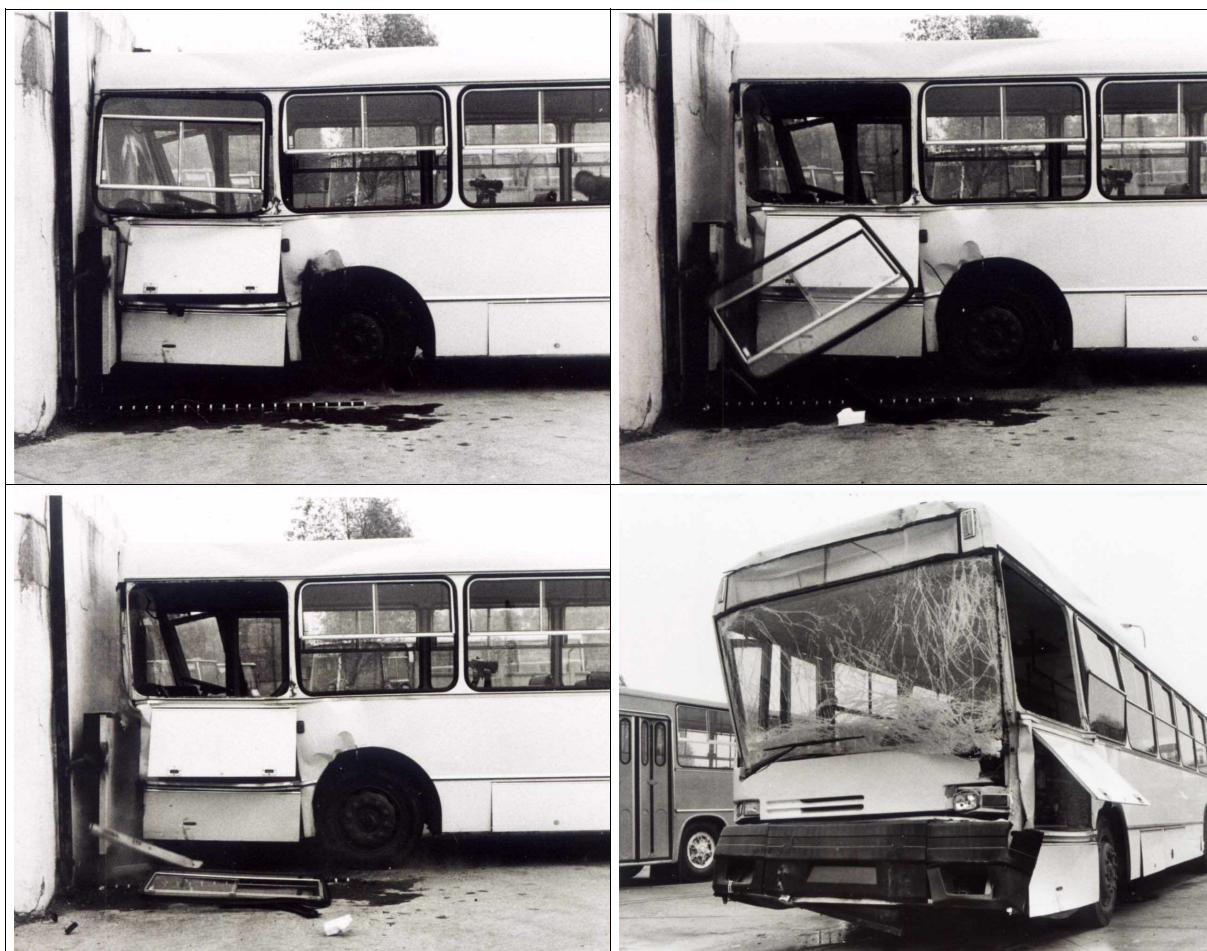
Figure 2a-d. Phases of frontal impact with 29,76 km/h speed; the front-wall wrinkled up onto the wooden impact surface which measured distance was 250 mm from the concrete block and the roof's edge reached the block too.

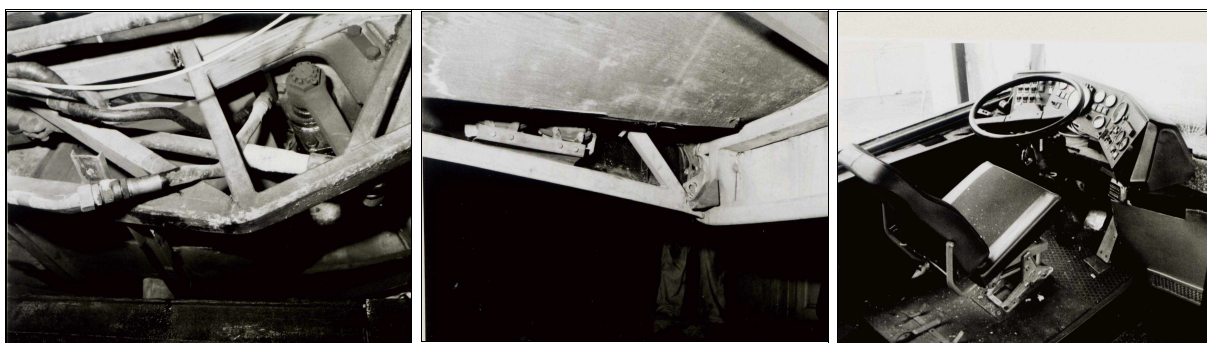
Figure 3a-c. Consequences of the 29,76 km/h speed impact

The left beam has suffered significant deformation after the 29,76 km/h speed impact; 130 mm was the measured specific compression. (**Fig. 3.a.**) On the right beam the measured compression was less, only 80 mm. (The left side is less rigid as the right one due to the left-side front door-frame.) The

driver seat has slid back thanks to the driver safety platform and the dashboard has cracked. The free distance between the steering wheel and the frontal surface of driver seatback was 330 mm, which ensures the survival due to the safety platform. (**Fig. 3.b-c.**)
